**Applying External Corrosion Direct Assessment (ECDA)
to Difficult to Inspect Areas**

**US Department of Transportation
Pipeline and Hazardous Materials Safety Administration**

Contract No. DTRS56-05-T-0003

March 2007

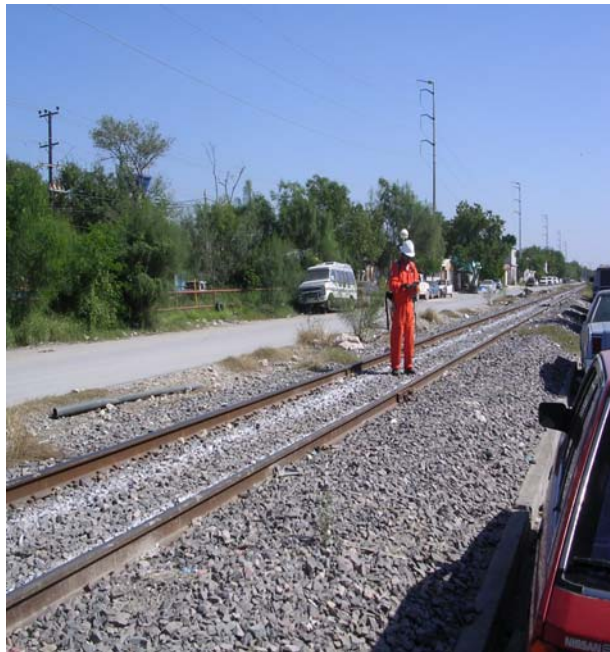
Figure 4. Operator B rail crossing

Two small ACVG indirect inspection responses were found within the rail crossing and no indications were found in the stream crossing. The indirect inspection results in this area and those nearby upstream and downstream are summarized in Figure 6. This visual tabulation illustrates signal level as well as the extent of the indications in the vicinity of this work.

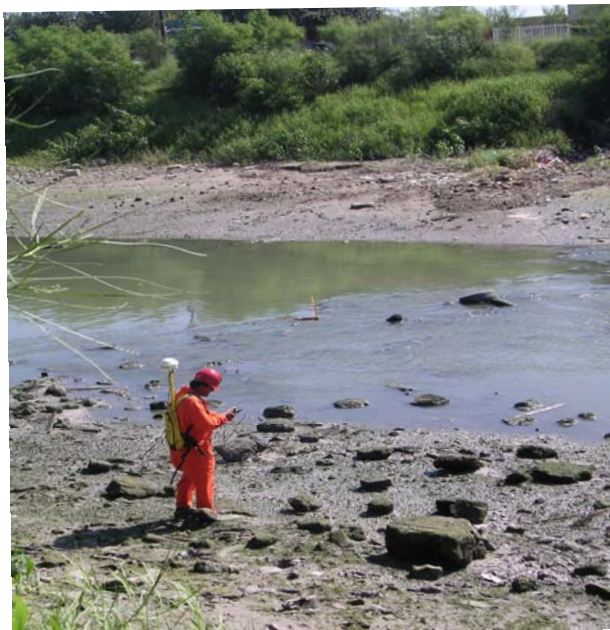
Figure 5. Operator B stream crossing

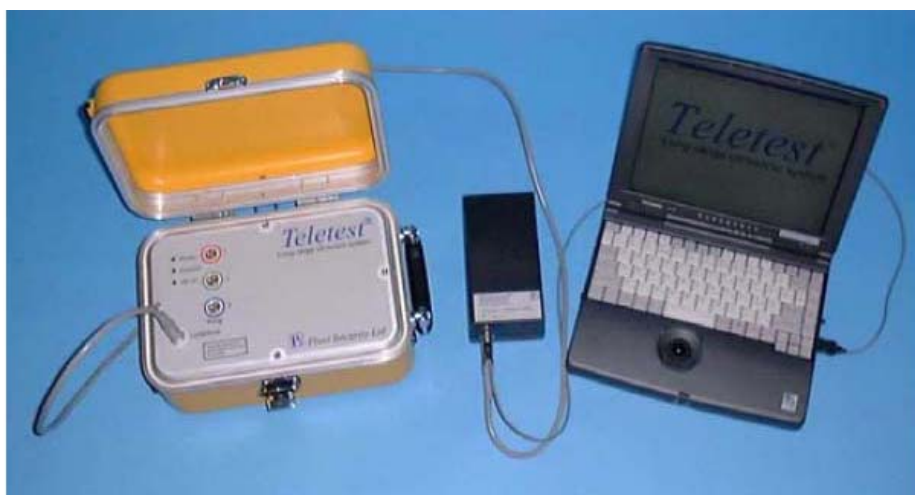
Figure C1. Teletest signal conditioning and recording equipment

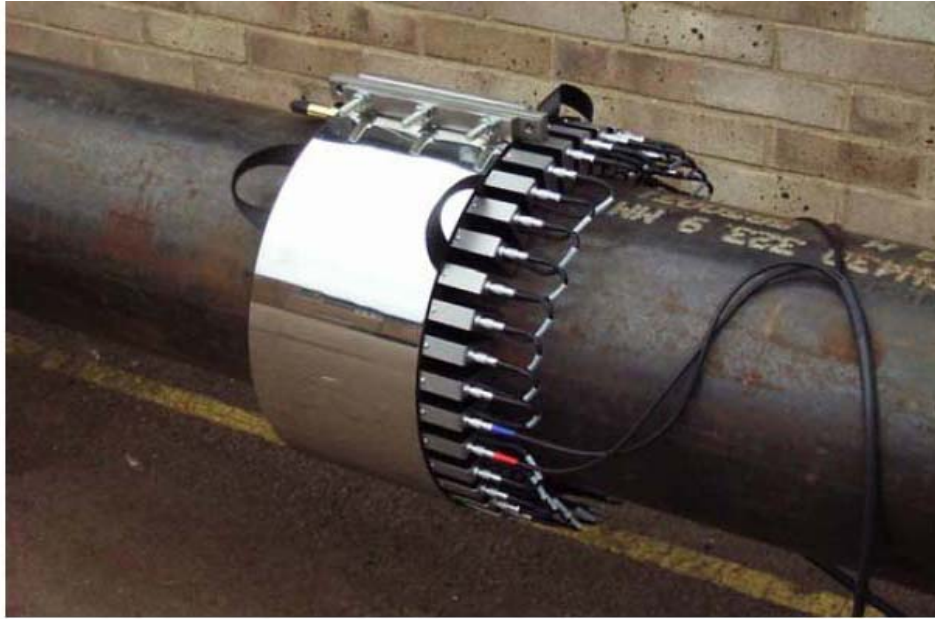
Figure C2. View of Teletest transducer set on a 12-inch diameter pipeline

around the pipe, as illustrated by the Teletest equipment in Figure C2 and GUL G-3 equipment in Figure C3. The use of low frequencies is necessary to generate the appropriate wave modes. At such frequencies a liquid couplant is not needed between the transducers and the surface, with satisfactory ultrasonic coupling achieved via mechanical or pneumatic pressure applied to the back of the transducers to maintain contact with the pipe surface. The uniform spacing of the ultrasonic transducers around the pipe circumference allows guided waves to be generated, which propagate symmetrically about the pipe axis. These may be visualized as a circular wave that sweeps along the pipeline. The full pipe wall thickness is excited by the wave motion, with the pipe wall acting as the wave-guide – hence the terminology guided wave UT. The propagation of these guided waves is governed principally by the frequency of the wave and the material thickness.

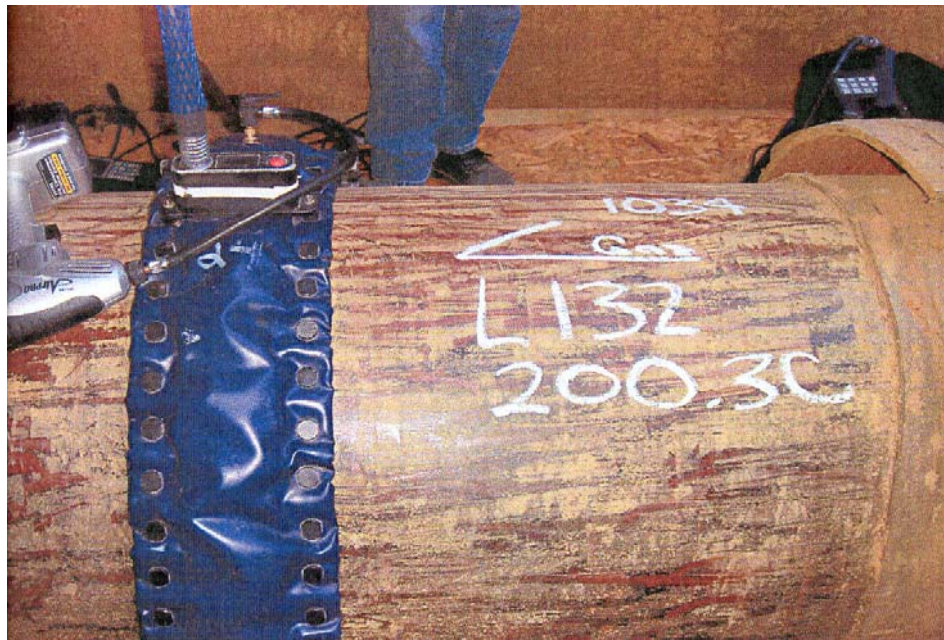
Figure C3. GUL G-3 LRGWUT Transducer Installation on Large Diameter Pipe
